## RESHARPENING IMPELLER BLADE LEADING EDGES

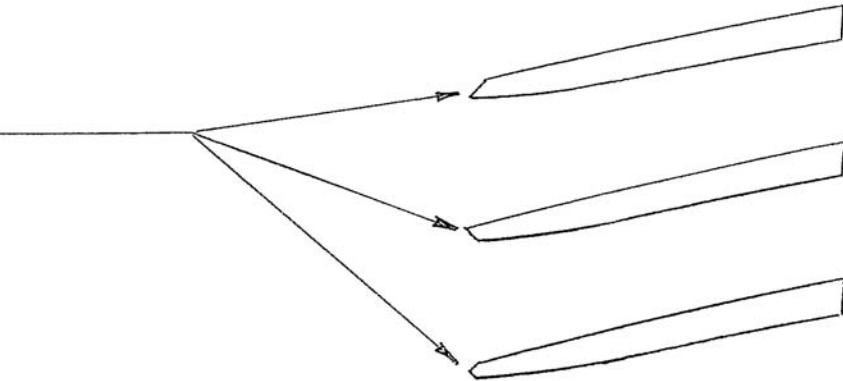
CAUTION: Do not bevel leading edge of blade as shown.
